ON-SITE AIR BAG INVESTIGATION

CASE NO. - 96-08

FLEET - PRIVATE VEHICLE

LOCATION - PENNSYLVANIA

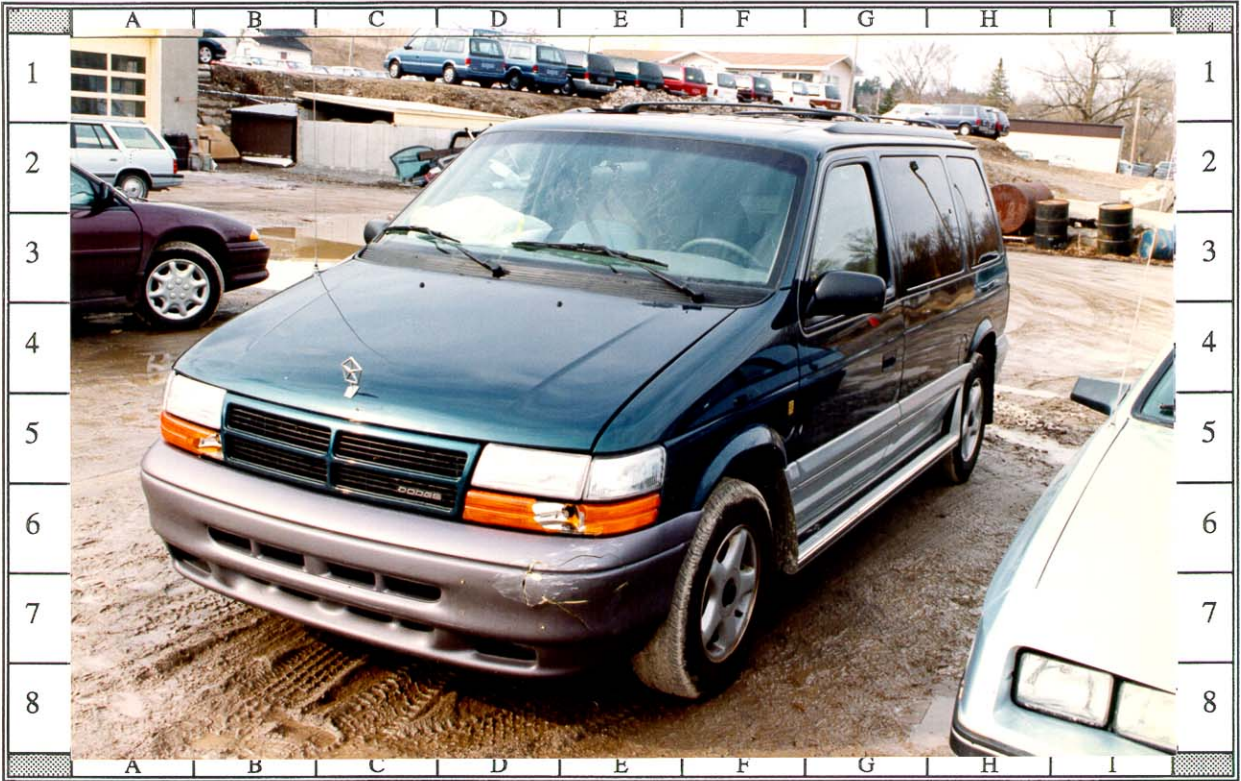
01: Case Vehicle's damaged front end; NOTE: bumper and radiator were replaced by used parts in order to make vehicle driveable back to Canada

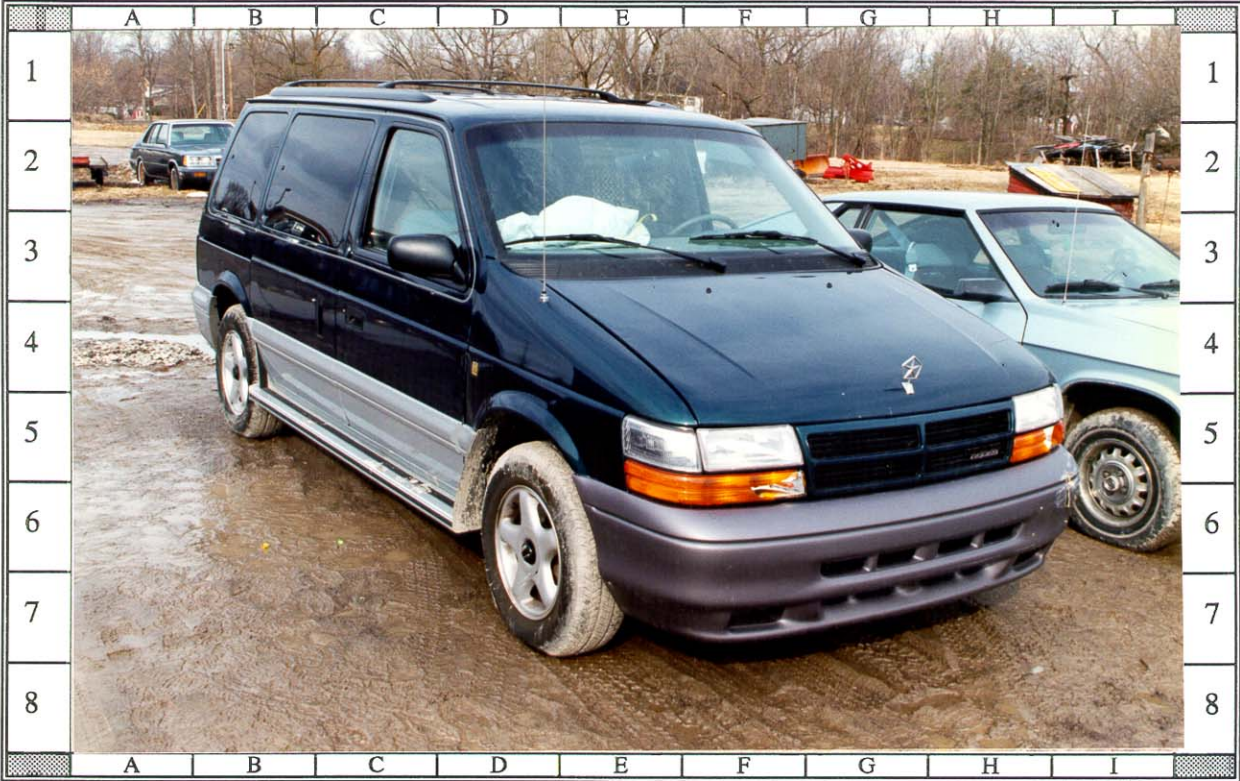
05: Case Vehicle's damaged front viewed from approximately 45 degrees right of front; NOTE: grille cracked and both amber turn signals broken out

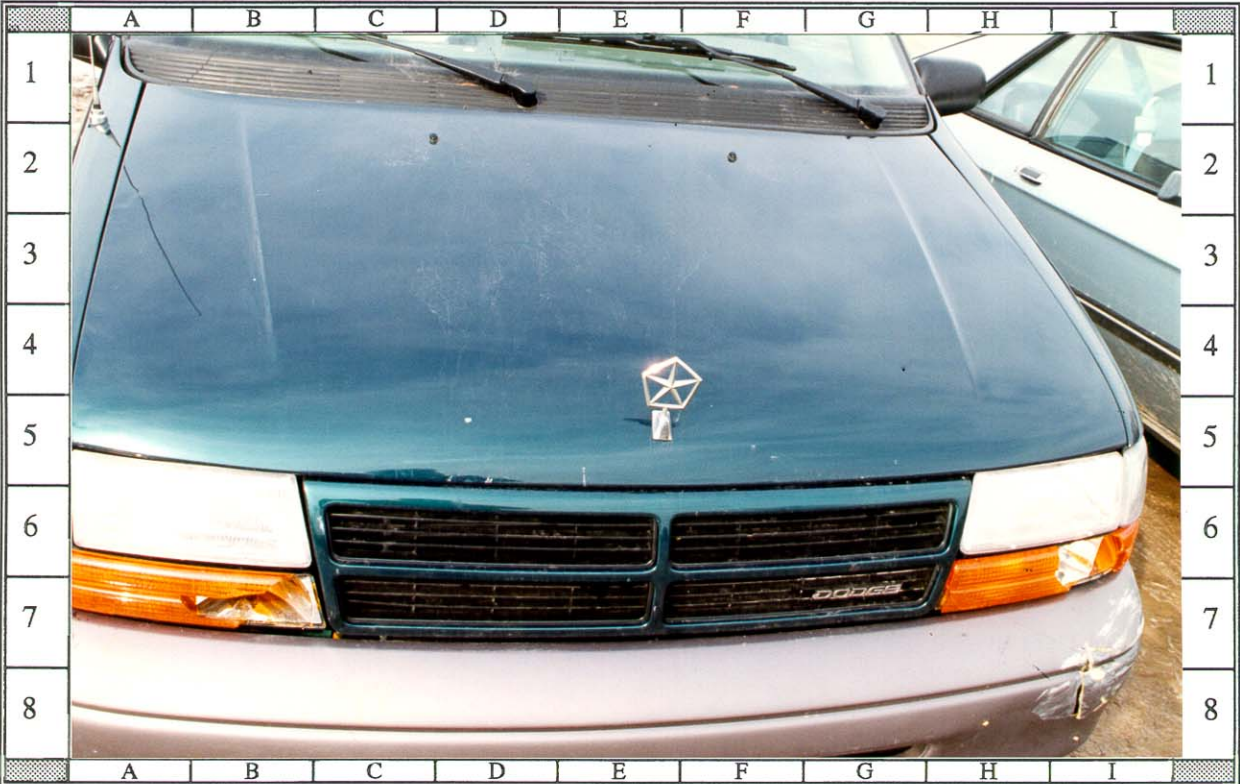
06: Close-up of case vehicle's damaged front end showing cracked grille, broken out left and right turn signals, and direct damage to hood edge (cells C5--D5)

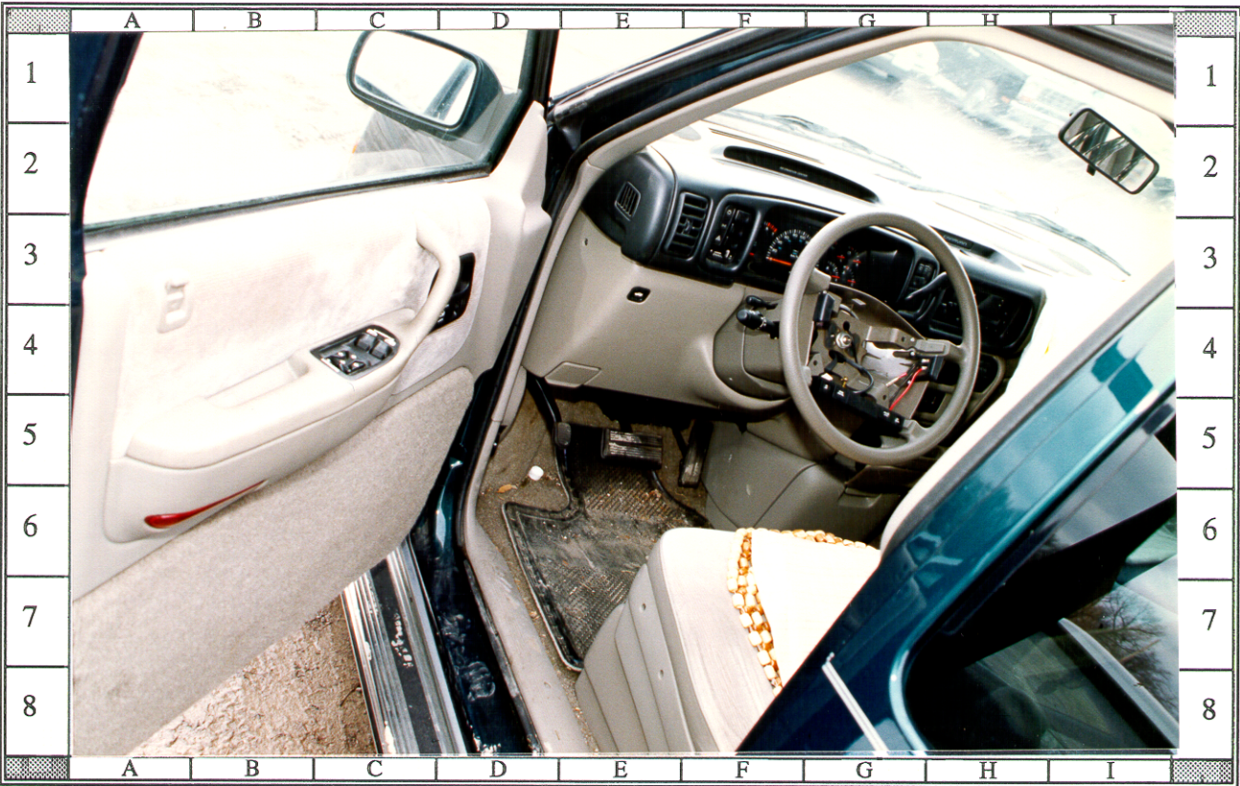
07: Case Vehicle's steering wheel, front dash area, and interior surface of driver's door; NOTE: deployed air bag module was removed so vehicle could be driven

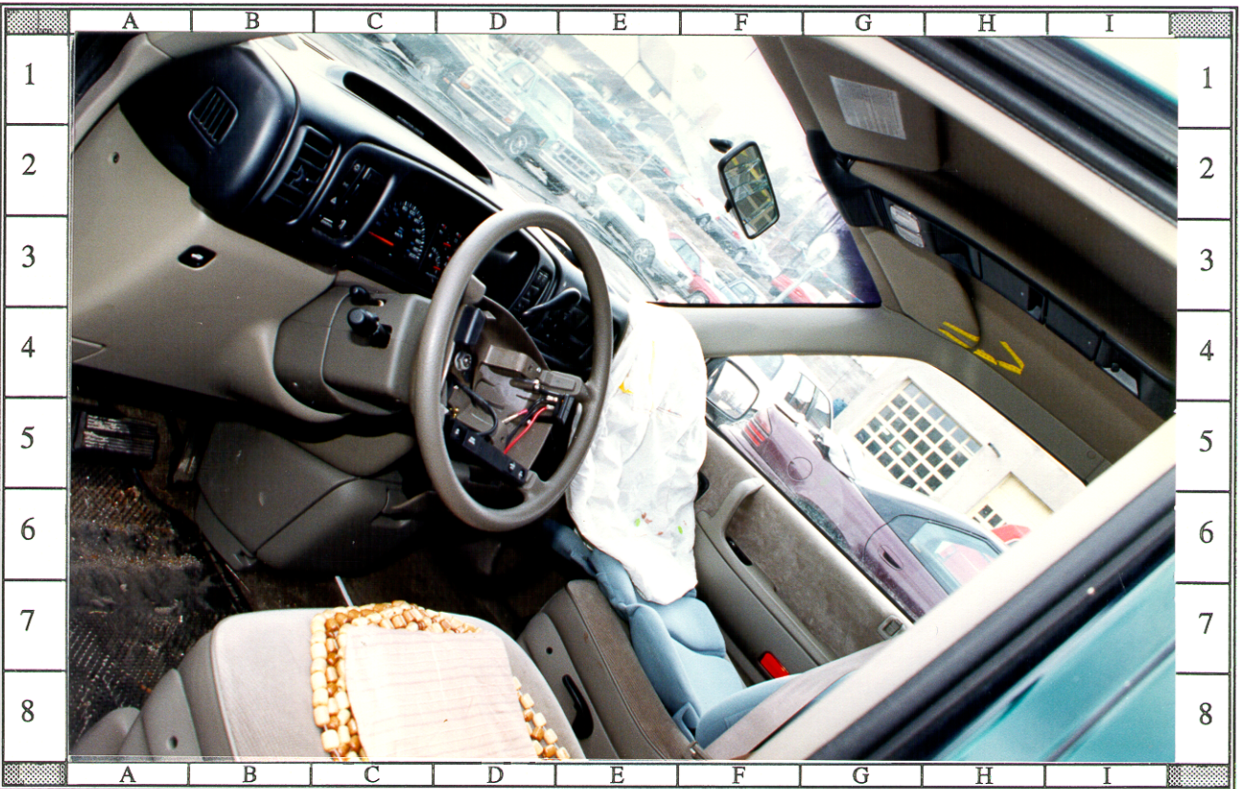
08: Case Vehicle's front seating area, steering assembly, instrument panel, and dash from left showing removed driver air bag and deployed passenger air bag

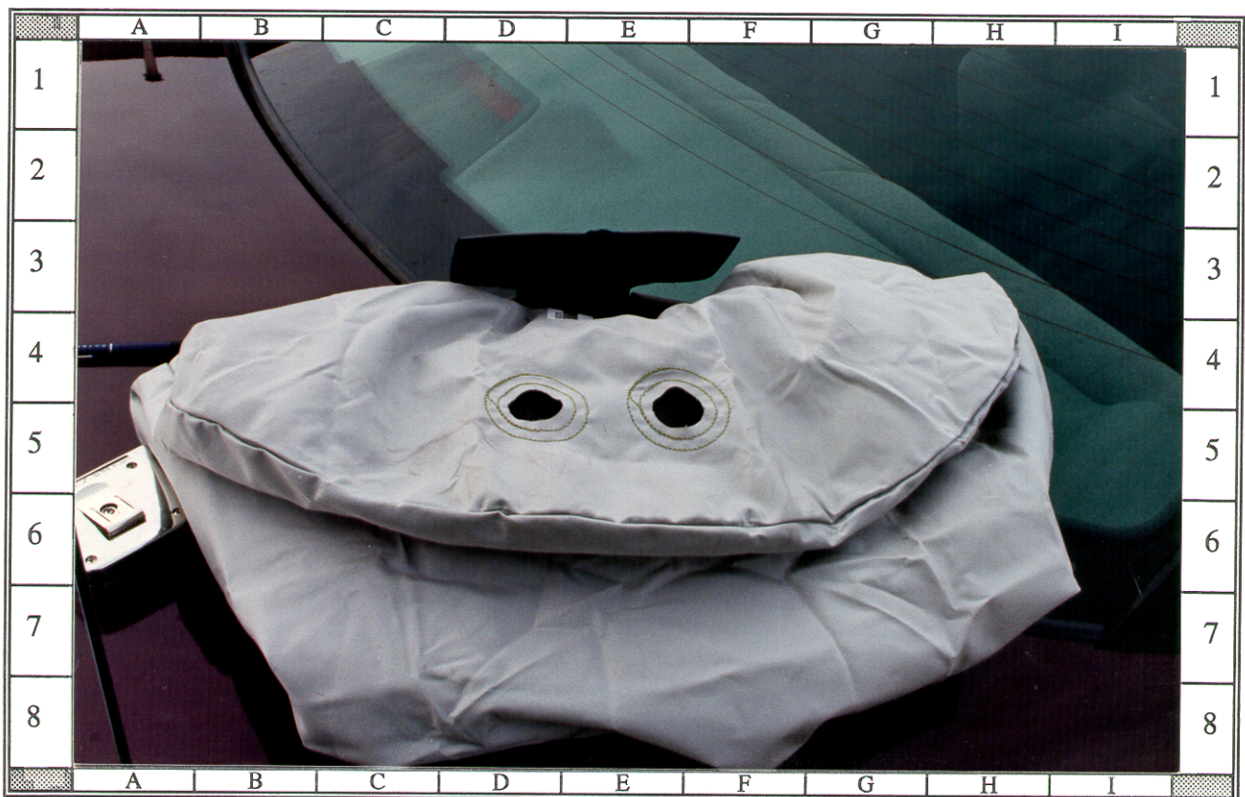
12: Case Vehicle's deployed driver air bag showing twin air vent holes located at approximately the 11:30 and 12:30 o'clock positions

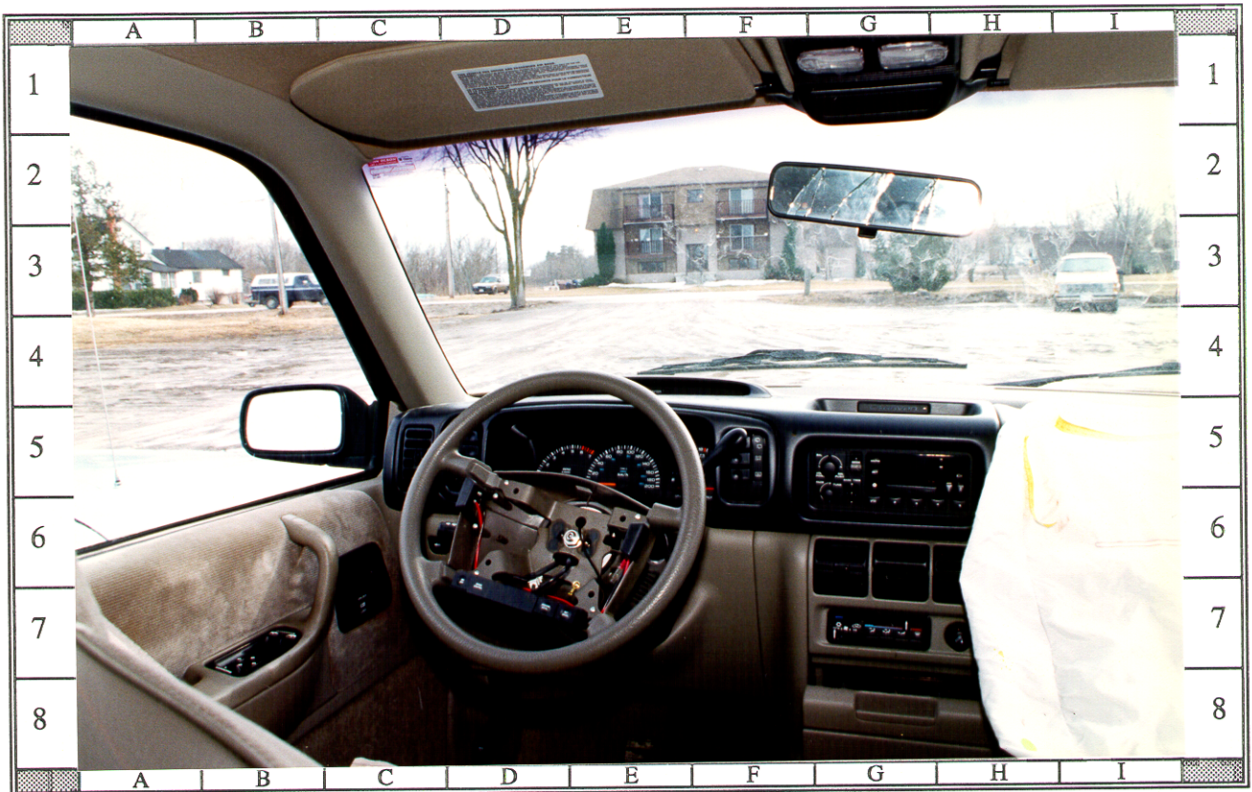
13: Case Vehicle's driver seating and center console areas showing no evidence of contact to greenhouse area; NOTE: cracked and displaced rearview mirror

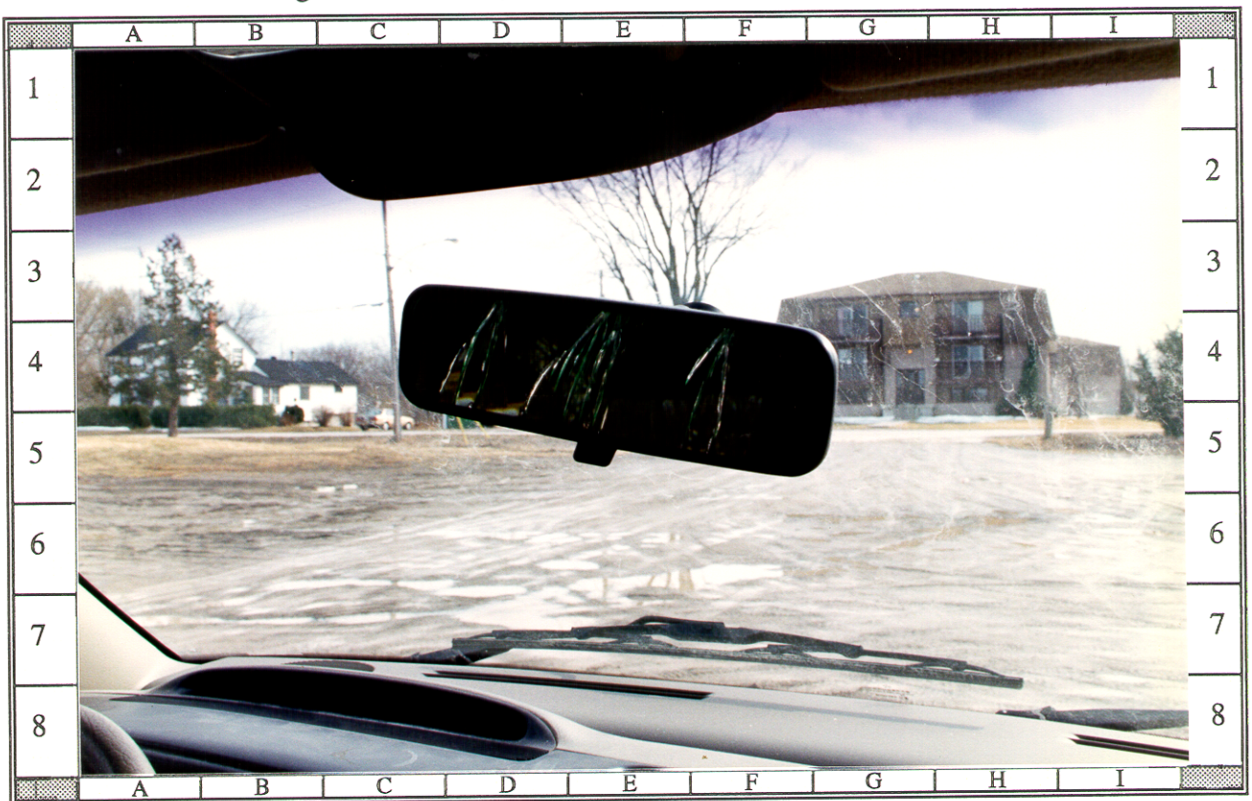
14: Close-up of Case Vehicle's cracked and displaced rearview mirror; NOTE: mirror was most likely cracked during deployment of passenger air bag

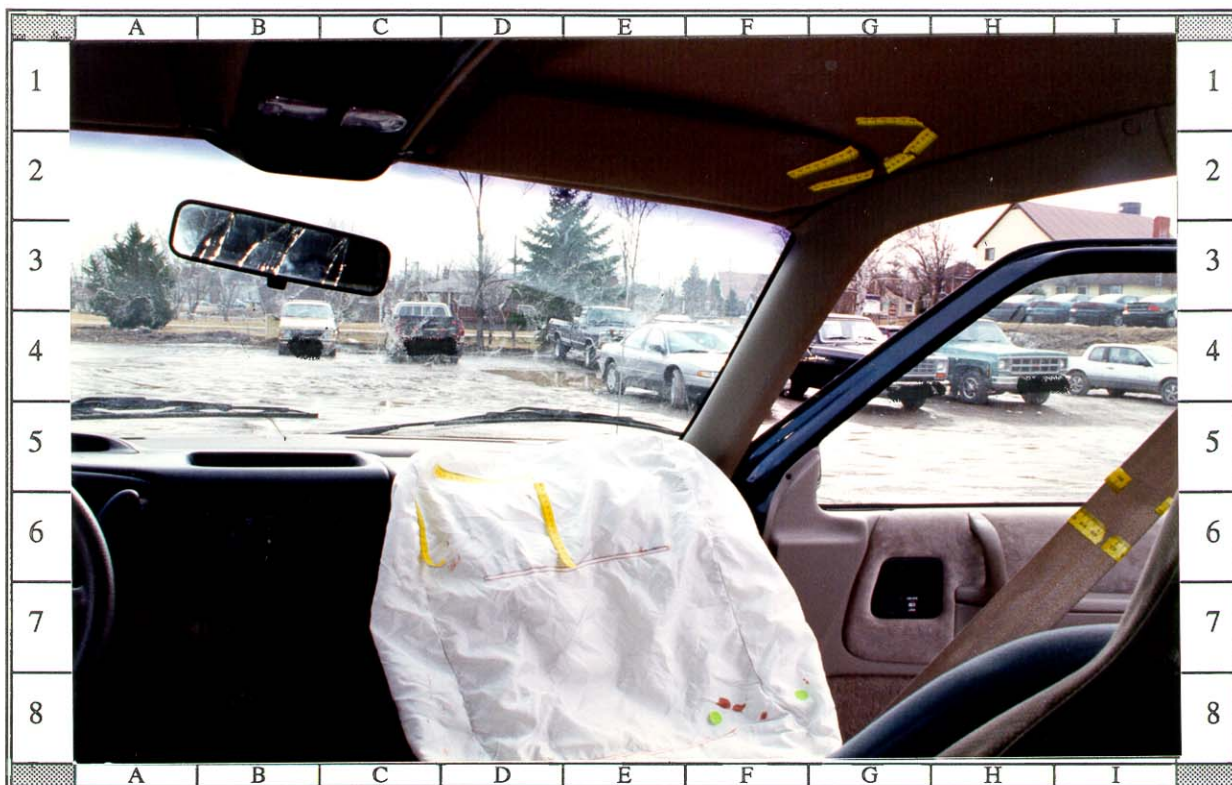
15: Case Vehicle's passenger seating area showing contacted air bag, damaged rear-view mirror, and other contacts to right side sunvisor and roof

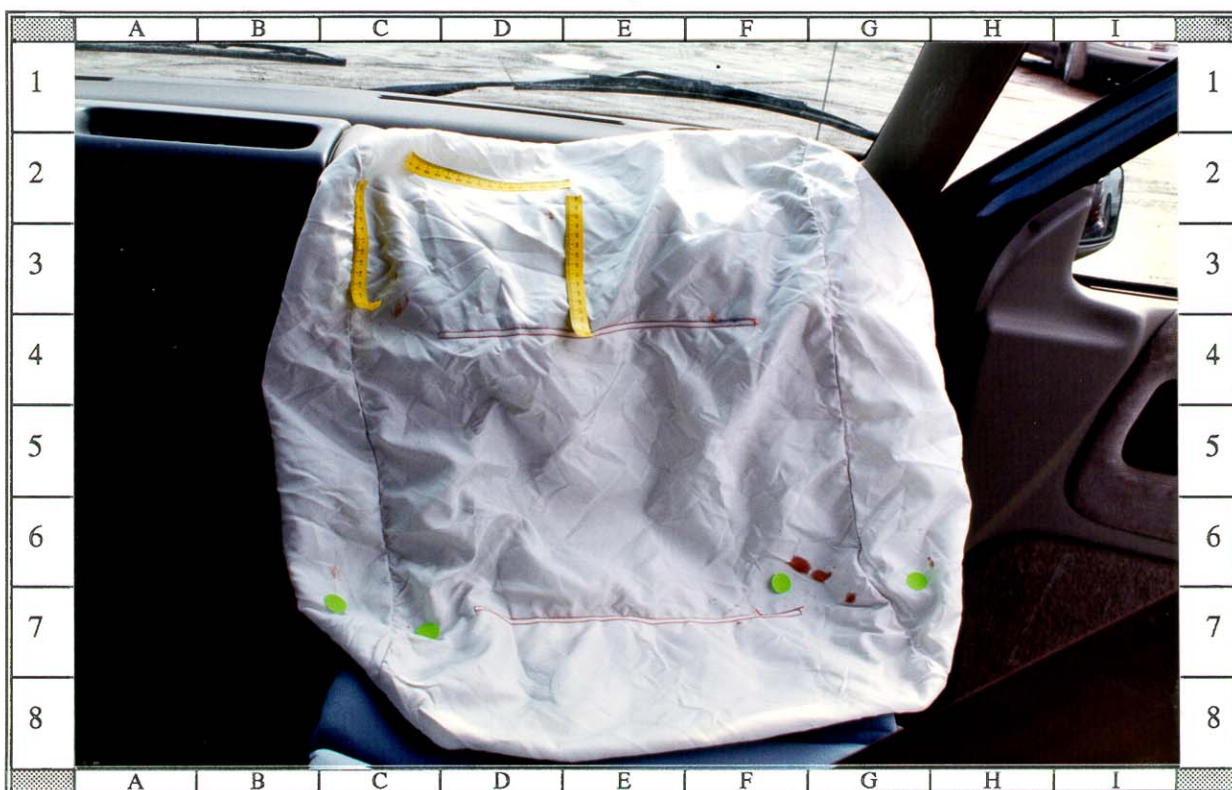
16: Close-up view of Case Vehicle's deployed right front passenger air bag showing contact evidence within taped area (cells C2--D3) and blood spots (cells F6--G6)

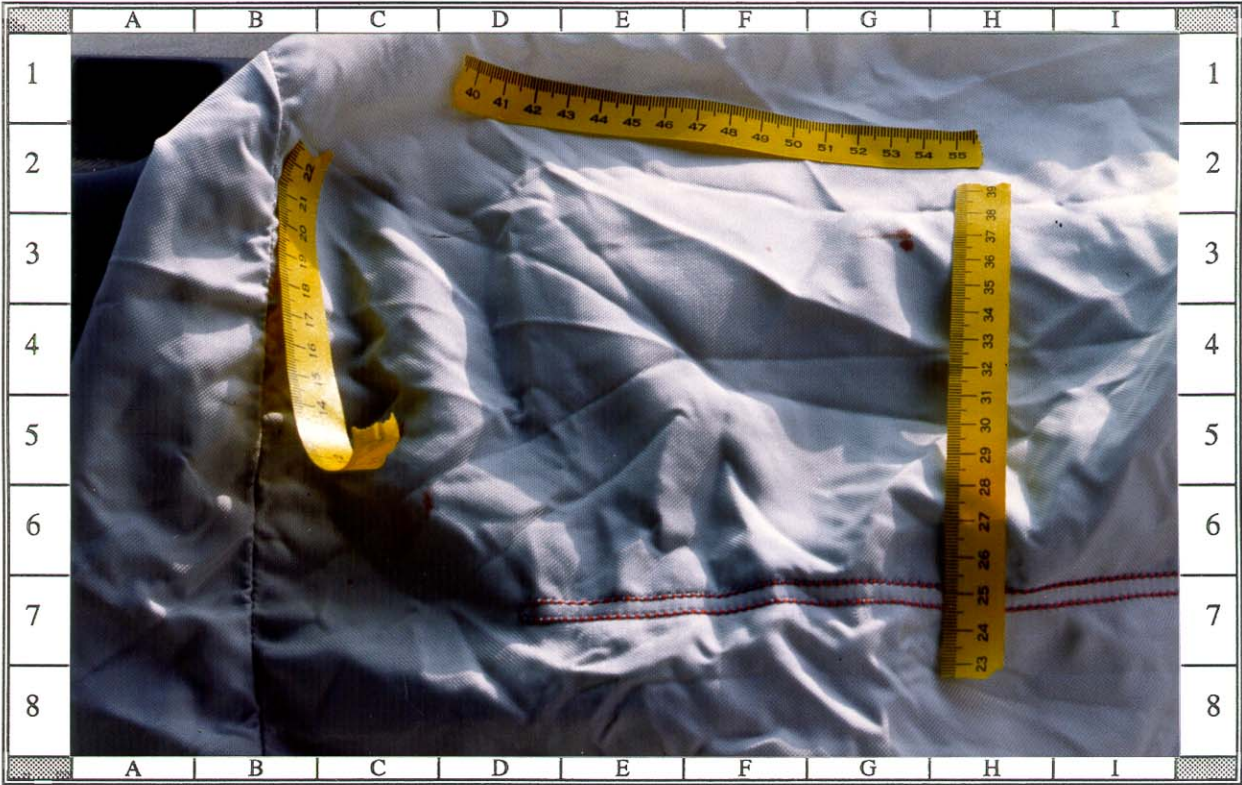
17: Closer-up view of Case Vehicle’s deployed right front passenger air bag showing highlighted contact area on deployed air bag; NOTE: red spots (cell G3)

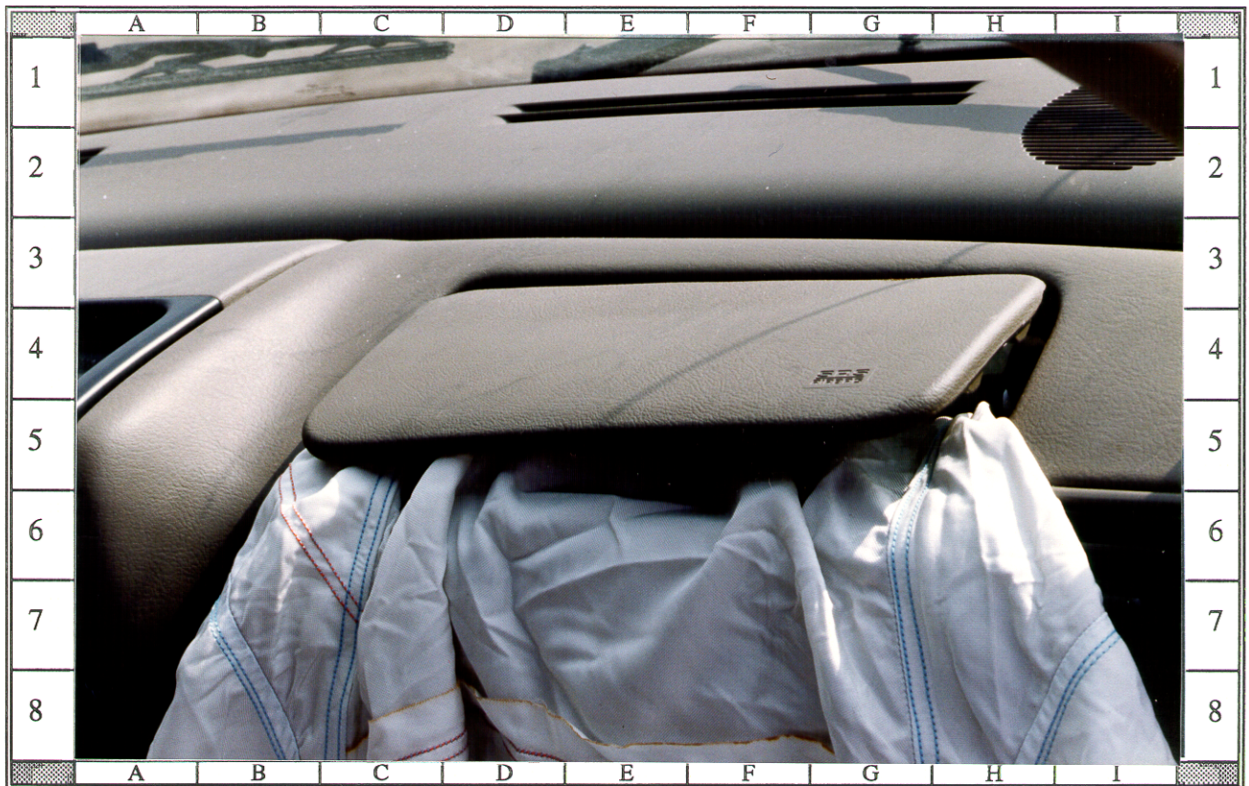
19: Close-up of module cover flap from Case Vehicle's deployed right front passenger air bag; NOTE: no evidence of contact on module's cover flap

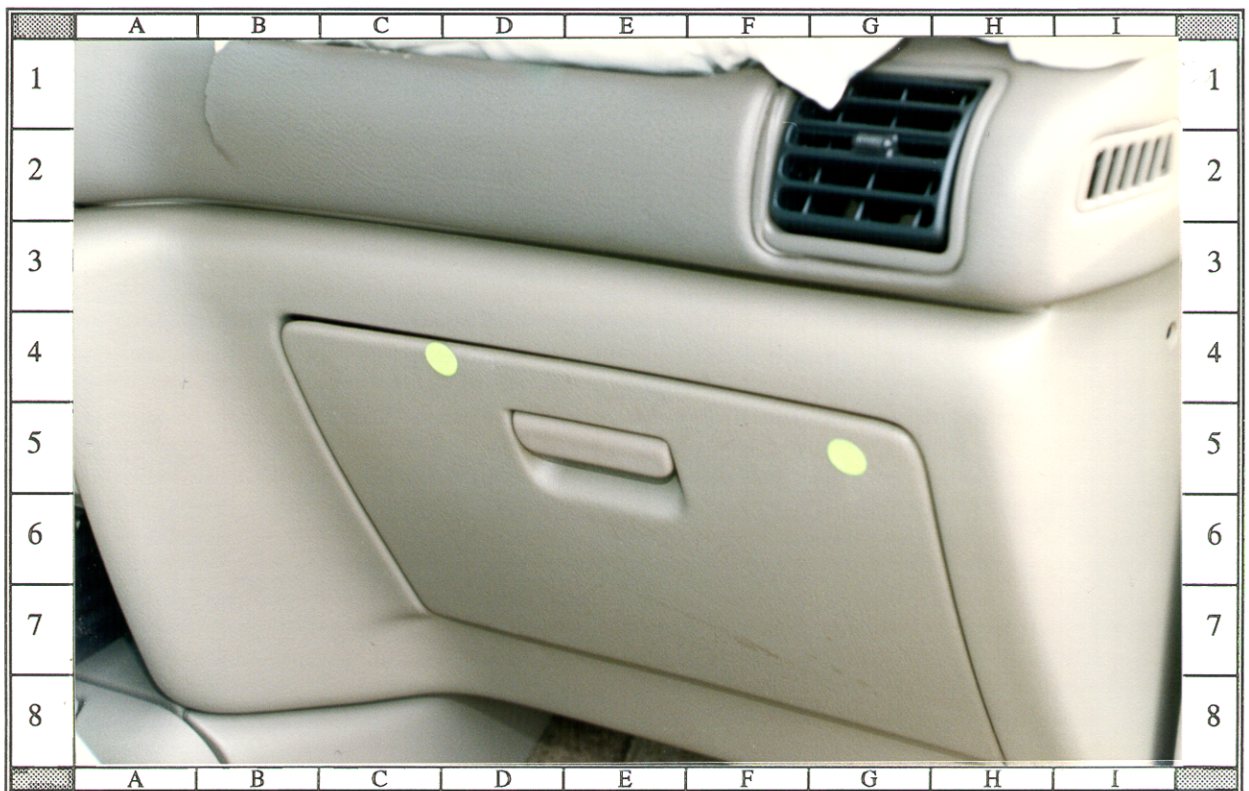
20: Case Vehicle's right knee bolster area and glovebox door, which was most likely contacted by passenger's knees; NOTE: crack below left side of cover flap

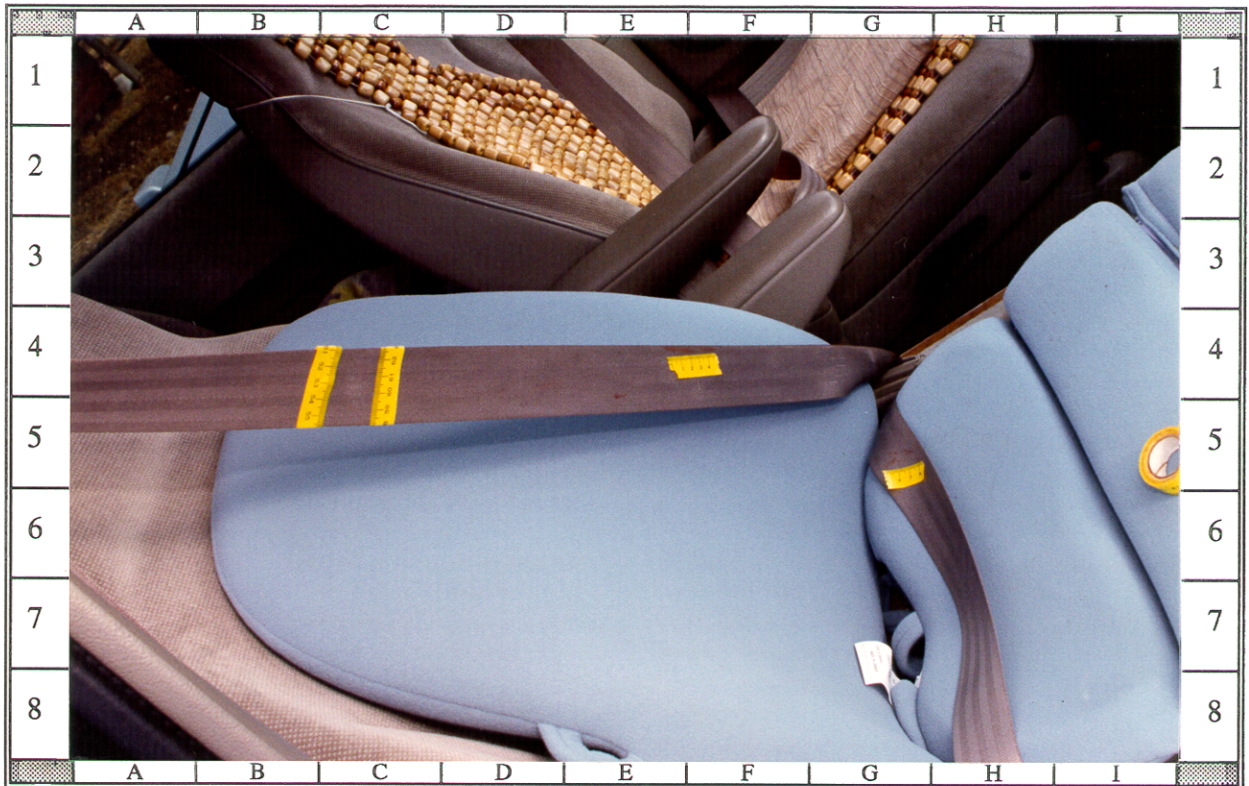
23: Case Vehicle's right front, 3-point, lap and shoulder belt showing passenger's skin transfer and blood stains on webbing (i.e., taped areas)

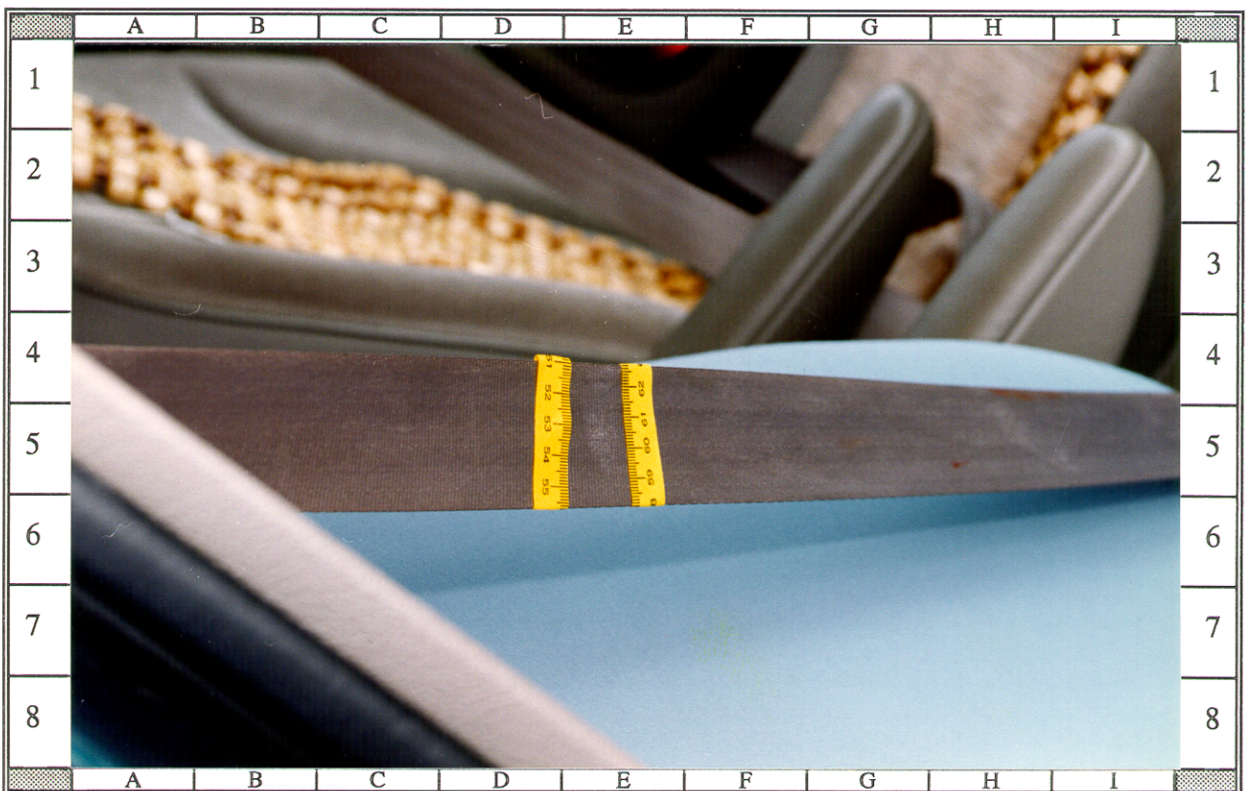
24: Close-up of skin transfer on torso webbing, near right shoulder area, of Case Vehicle's right front, 3-point, lap and shoulder belt, confirming usage

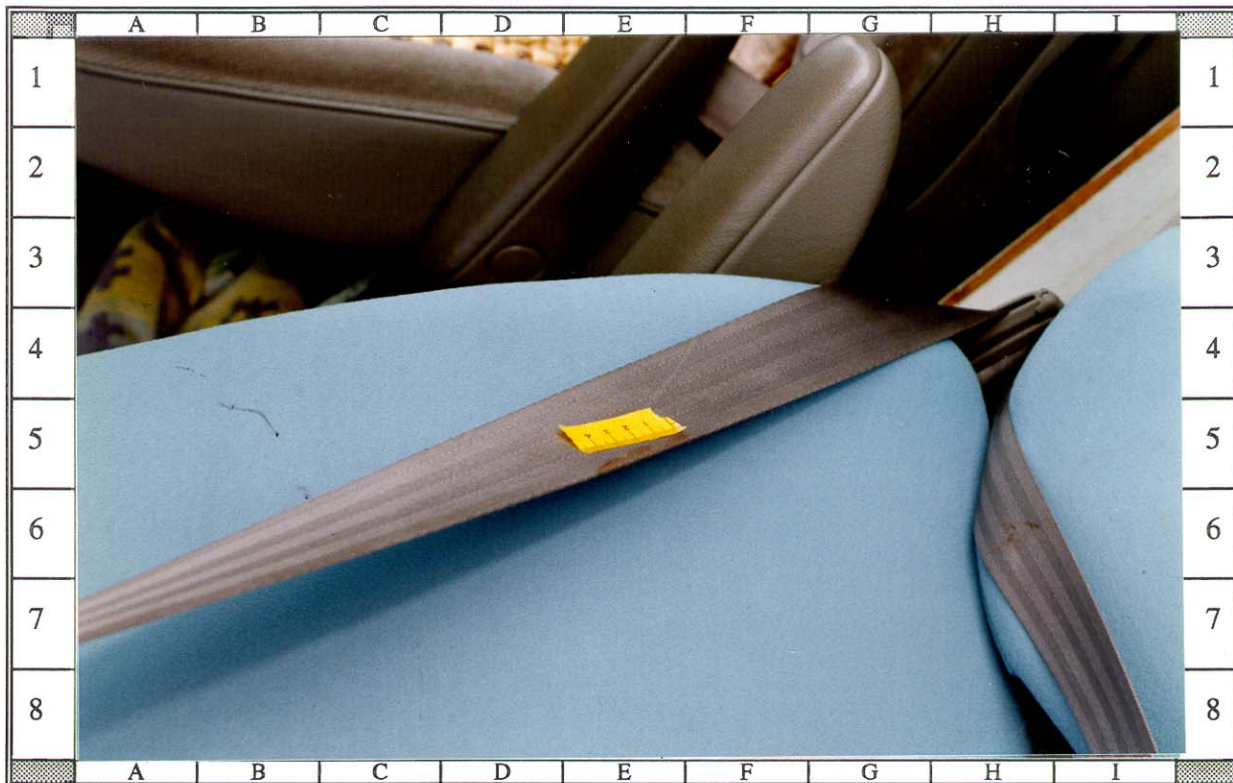
25: Close-up of blood stain on torso webbing, near center of chest, of Case Vehicle's right front, 3-point, lap and shoulder belt, confirming usage

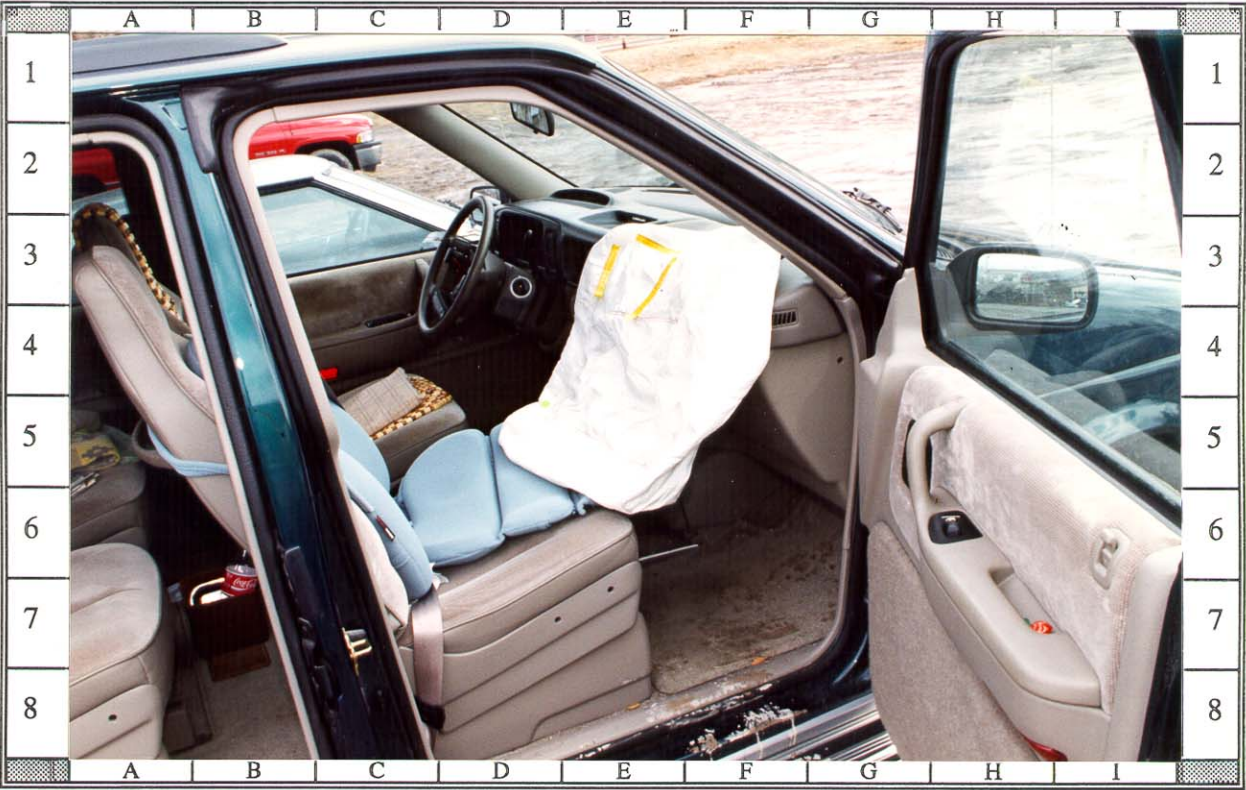
27: Case Vehicle’s front seating area, steering assembly, and interior surface of passenger’s door showing deployed and contacted passenger air bag

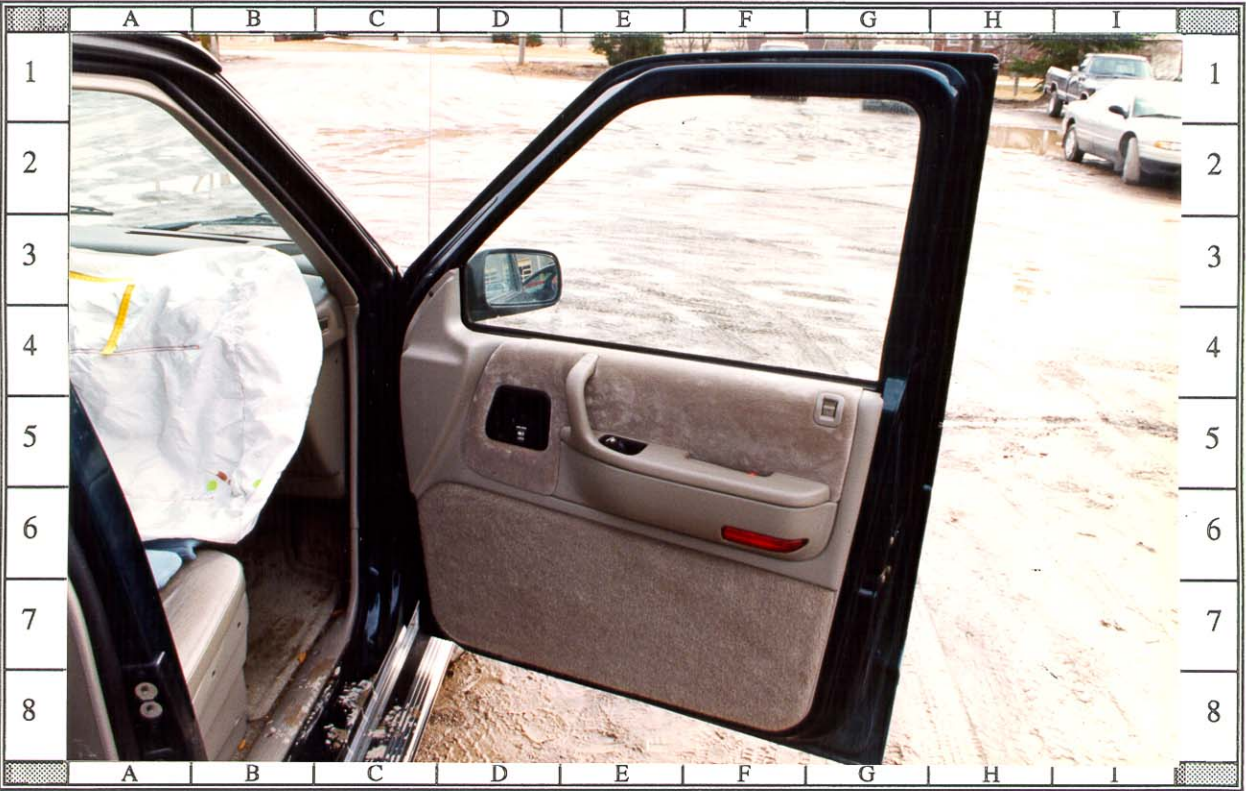
28: Interior surface of Case Vehicle’s right front door and window; NOTE: no evidence of contact
